Site Name: <u>Progress Energy Asheville</u>	Date: <u>29 MAY 2009</u>
Unit Name: <u>1964 POND</u>	Operator's Name: <u>PROGRESS ENERGY</u>
Unit I.D.:	Hazard Potential Classification: <u>High</u> Significant Low
Inspector's Name: <u>FREDERIC SHMURAK / JUSTIN STORY</u>

Site Name: Progress Energy Asteville Date: 29 May 2009
 Unit Name: 1982 Pond Operator's Name: PROGRESS ENERGY
 Unit I.D.: _____ Hazard Potential Classification: High Significant Low
 Inspector's Name: Frederic Shmurak / JUSTIN STORY

PHOTOGRAPH LOCATION PLAN
ASH PONDS - PROGRESS ENERGY
ASHEVILLE STEAM ELECTRIC PLANT
SKYLAND, NORTH CAROLINA

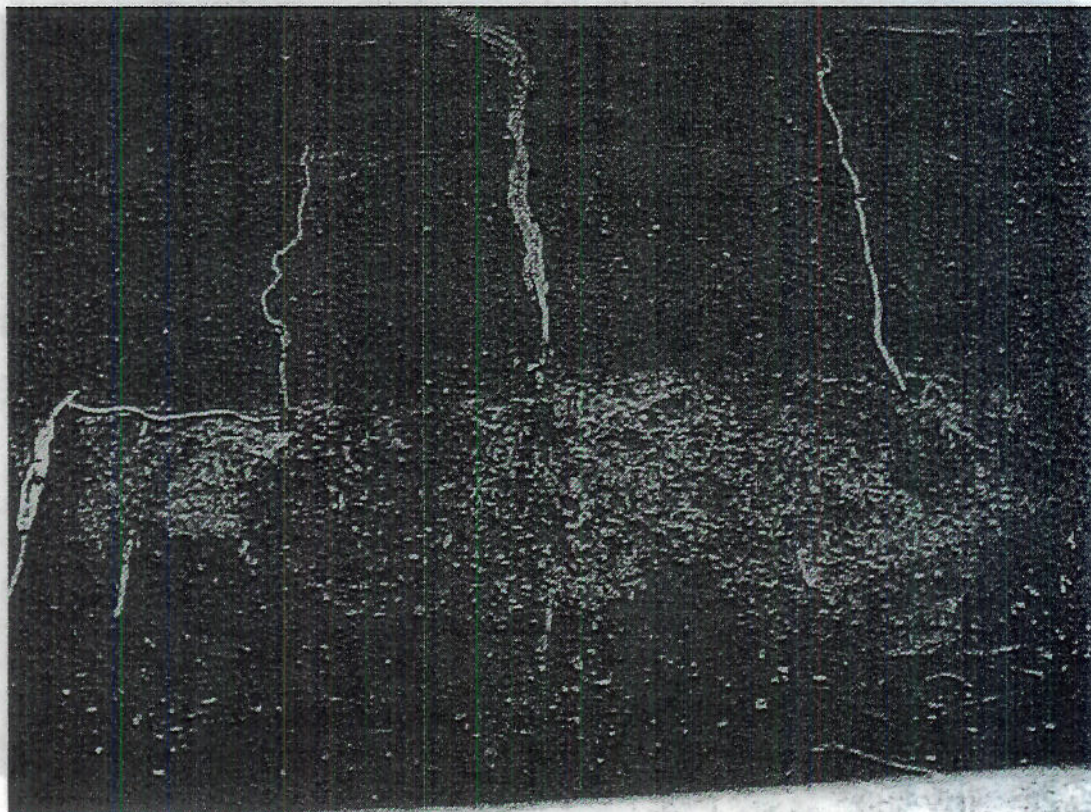
Photograph 8: Cooling Lake Dam – spalling concrete on ogee spillway.

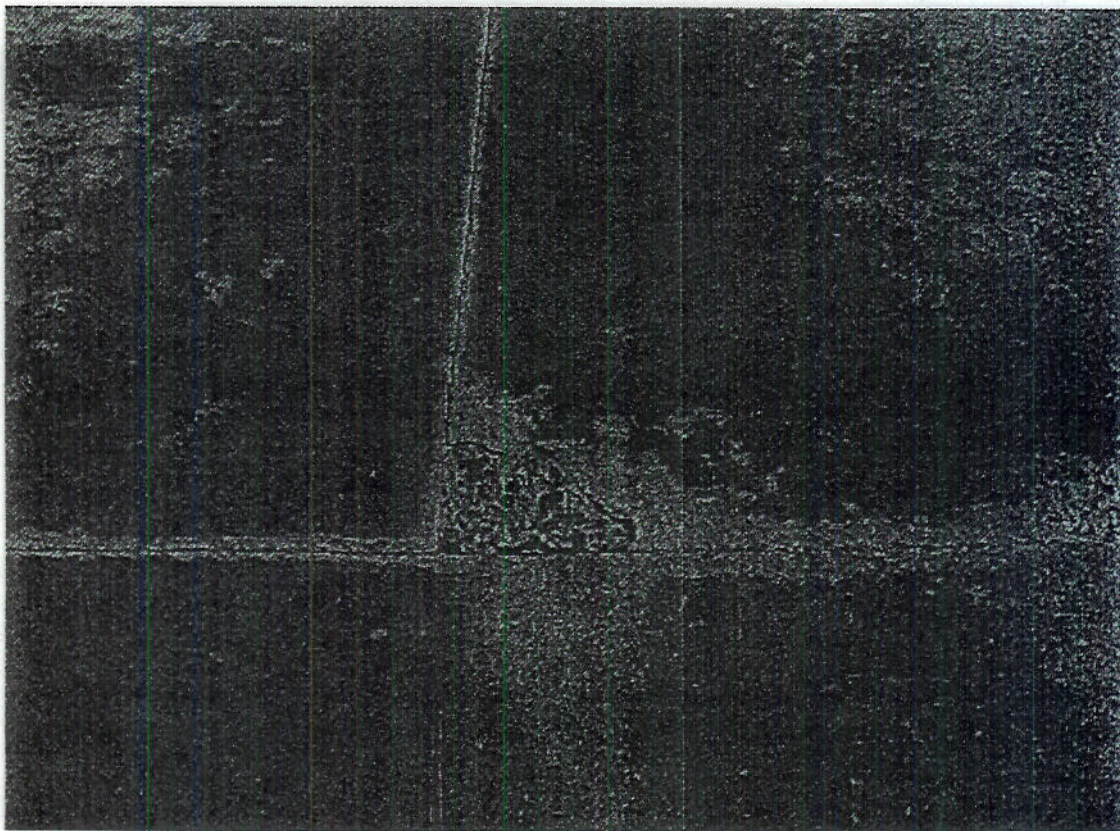
Photograph 10: Cooling Lake Dam – spalling concrete in spillway slab.

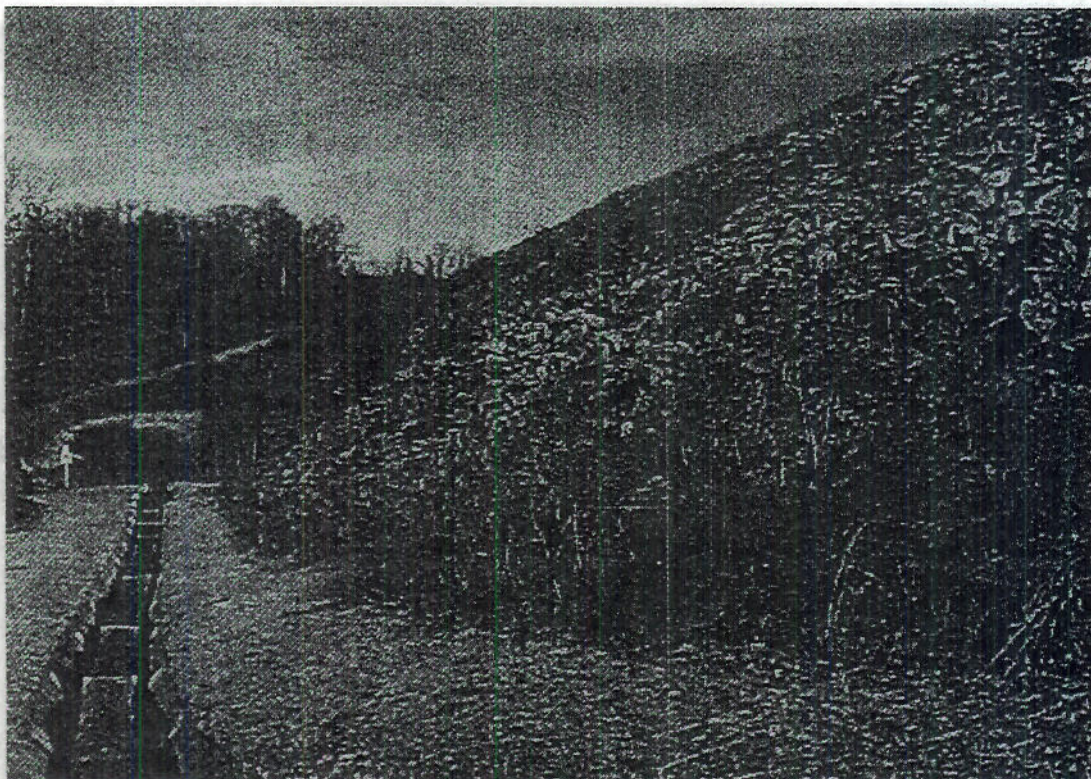
Photograph 13: 1964 Ash Pond – downstream slope looking northwest along toe of slope, note bushes growing in riprap.

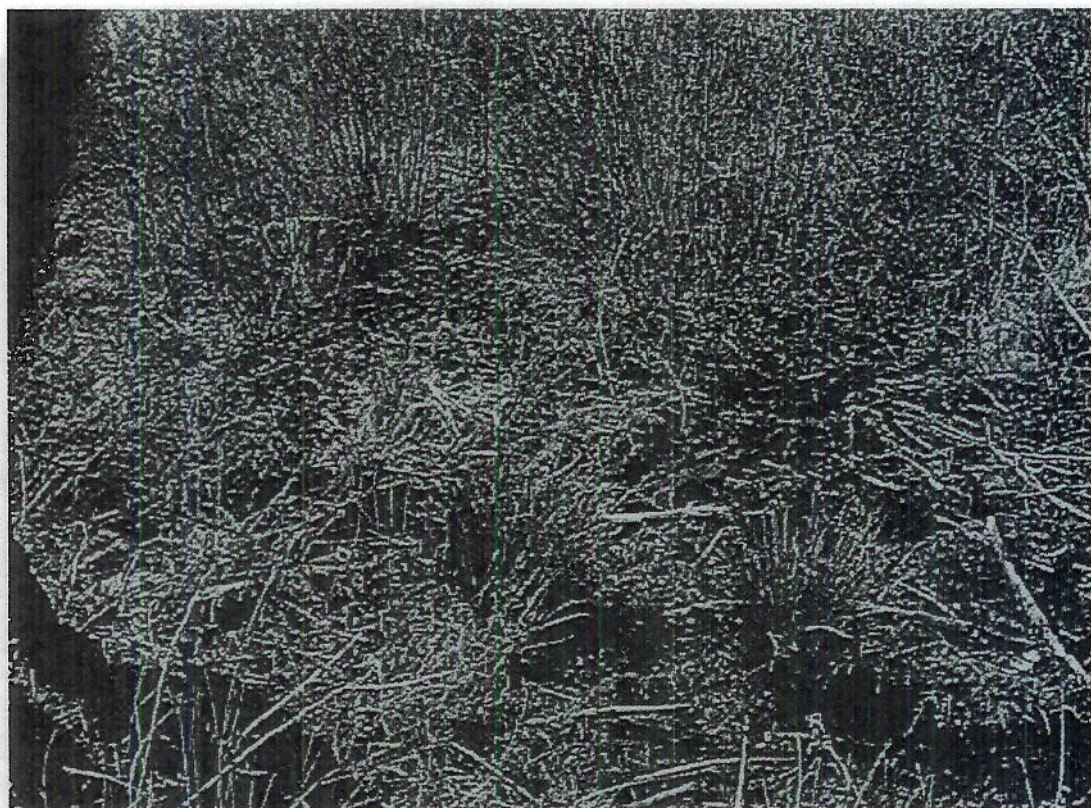
Photograph 14: 1964 Ash Pond – seepage at toe of embankment, north of stilling basin.

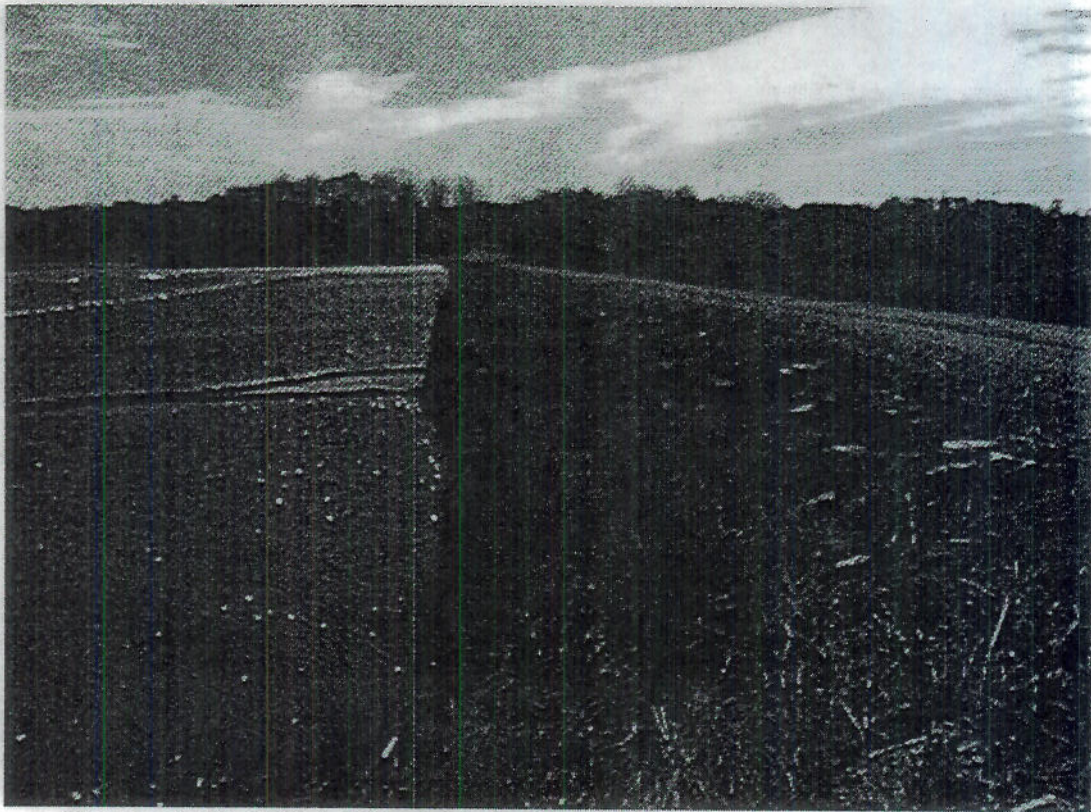
Photograph 15: 1982 Ash Pond, interior slope looking east, note vegetation in riprap.

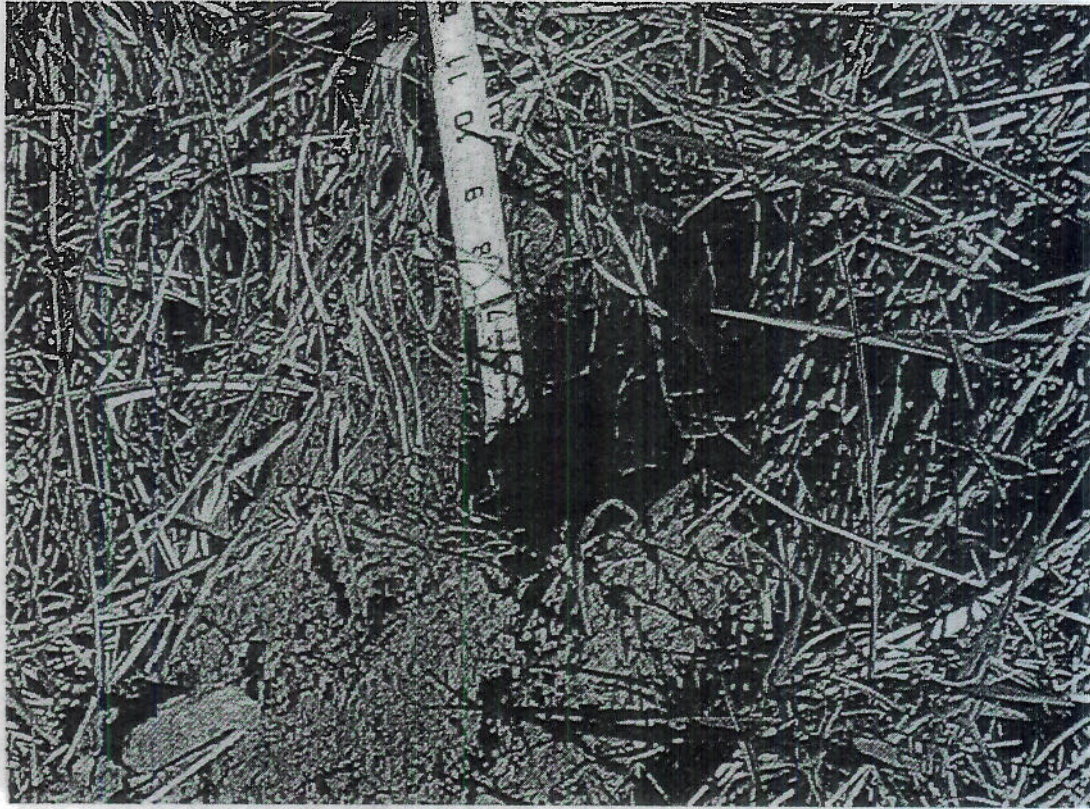
Photograph 19: 1982 Ash Pond – rodent holes in downstream slope.

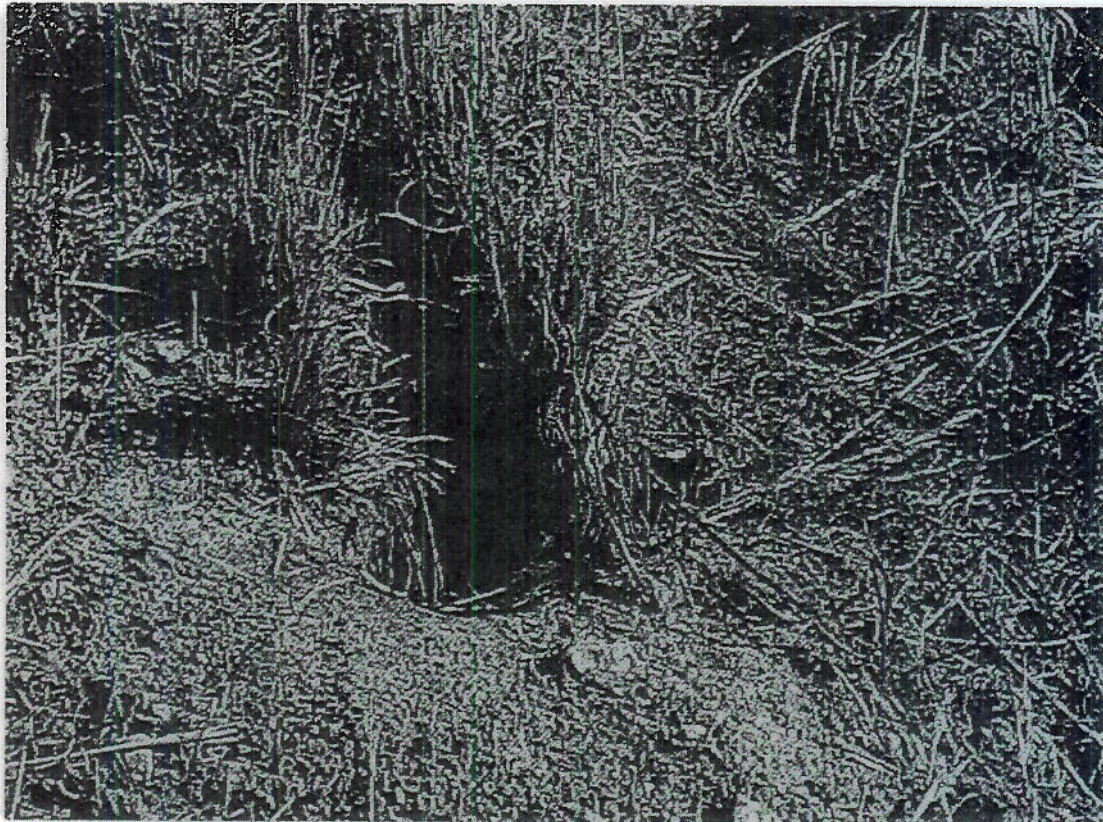
Photograph 20: 1982 Ash Pond – rodent holes in downstream slope.

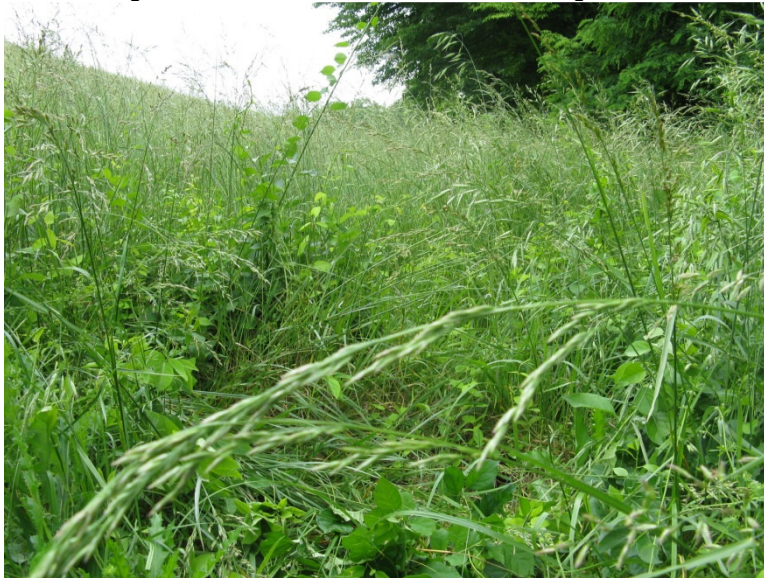
Photo 18: 1982 Dam – Minor Rill Erosion, Downstream Embankment, Photo: 033, 5/29/09
